# DEIMOS Service Mission, March 2016

*C. Alvarez, M. Kassis, S. Milner, J. Ward, E. James, A. Vandenberg*

This document reports on the service mission performed on the DEIMOS grating system between March 13 and March 28, 2016. The main work done on the system consisted of the following tasks:

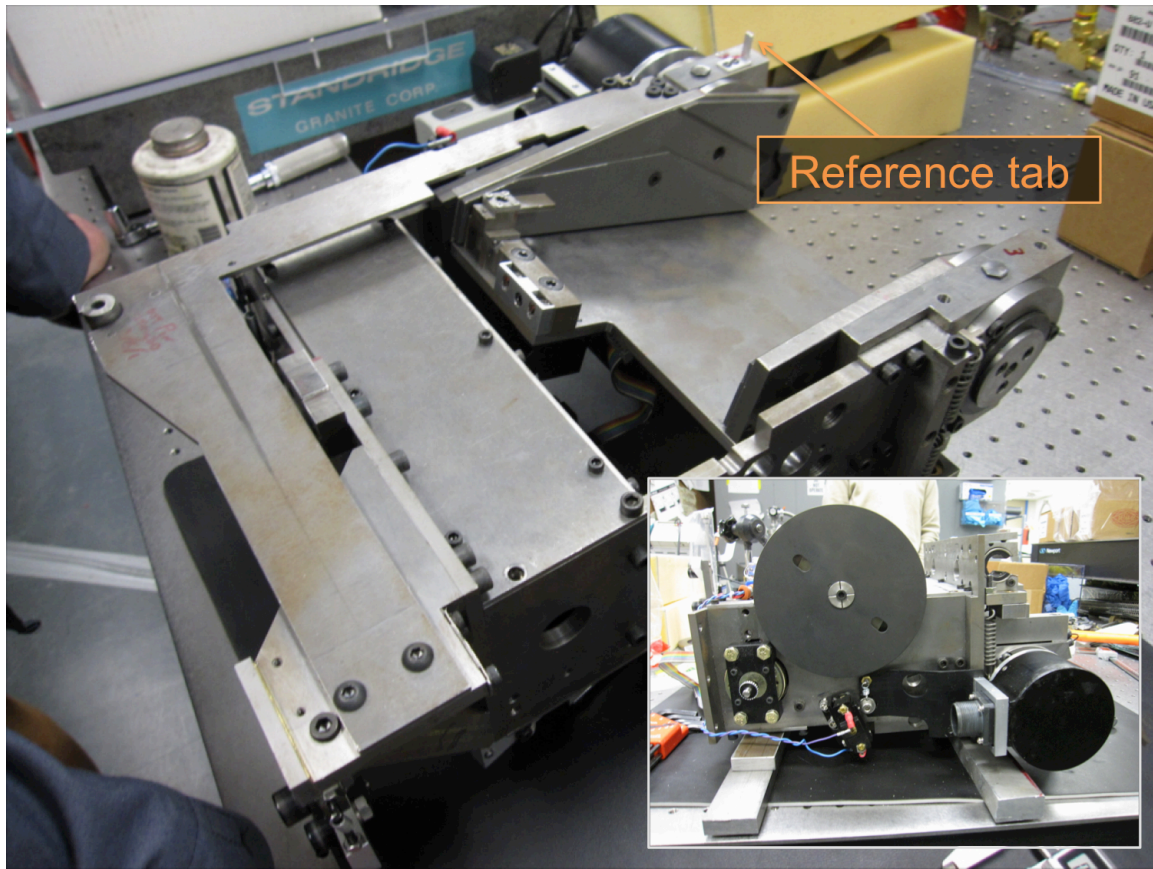
In the whole process, it is critical to make sure that the reference tab (see Figure 4) in the grating mechanism is not bent, otherwise the homing reference will be lost.

Figure 4: Grating cell showing the reference tab. The inset shows how we lifted the cell to prevent the tab from bending.

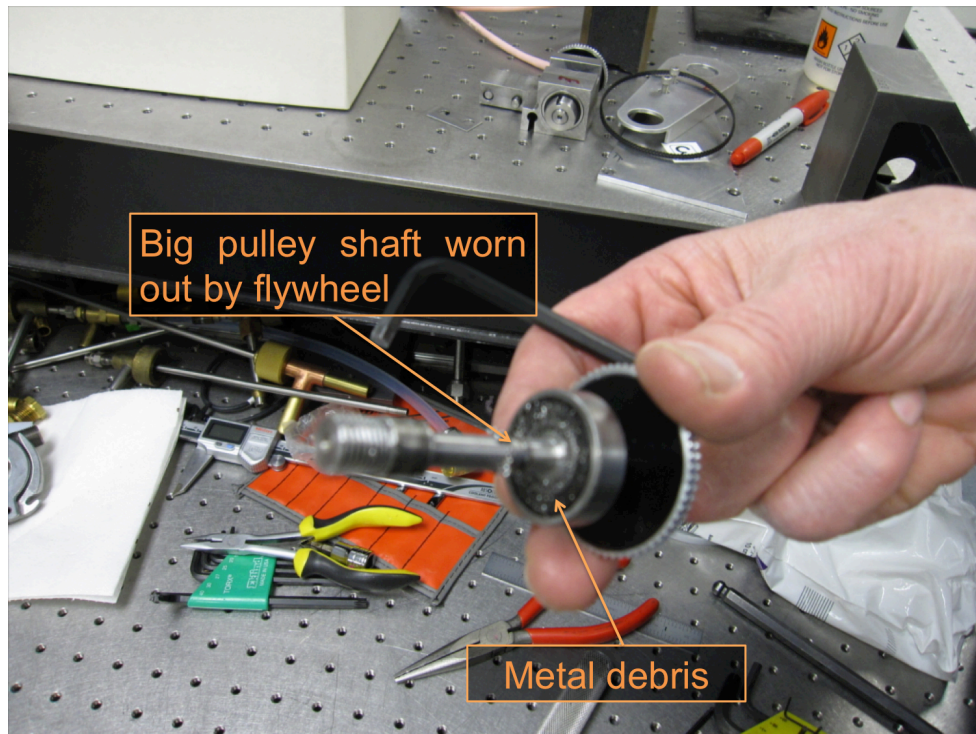
- In both grating cells, there was a lot of wear and tear in the flywheel shaft at the contact point with the arc.
- The old flywheel assembly on slider 3 was not round to 0.005" – 0.006".

Figure 5: Pulley axis and metal debris caused by friction between the flywheel and the pulley axis. New machined flywheels have a 2 deg bevel to prevent wearing the pulley axis.

- Installed rounder and more concentric flywheels. Wheels have beveled edges to prevent wearing of the belt pulley shaft.
- Optimized the concentricity of the flywheel-shaft assembly.

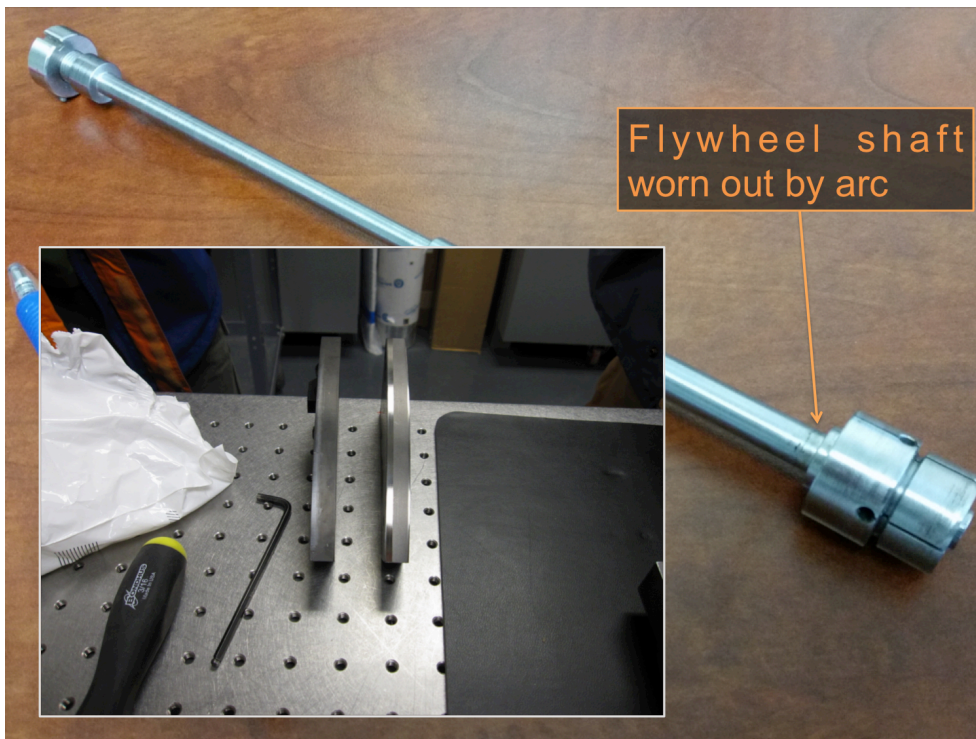
Figure 6: Flywheel shaft worn out by contact with arc. Inset shows the old arc (left) and the replacement arc (right), which has been machined with a beveled surface to prevent wearing the flywheel shaft.

- Installed new arcs with that were modified with a 2-degree tilt on one edge to prevent the arcs wearing out a large wheel shaft (see Figure 2 for an overview of the grating slider assembly).

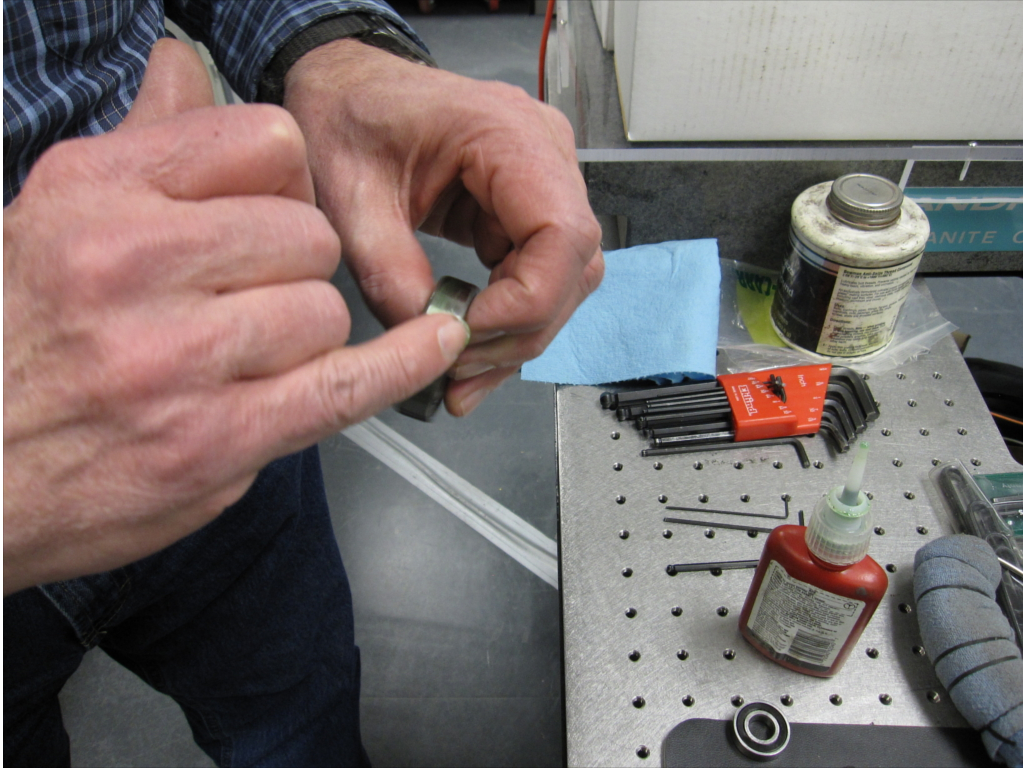
Figure 8: Applying Loctite 620 to the bearings holding the flywheel shaft in position.

One line of work to try to reduce the total run out was to apply Loctite 620 on bearings holding the flywheel shaft on the wheel side (see Figure 8). The procedure to apply the Loctite was:

1. To clean the bearing hole
2. To apply Loctite
3. To let Loctite sit for long enough (at least 1.5 hours, overnight if possible)

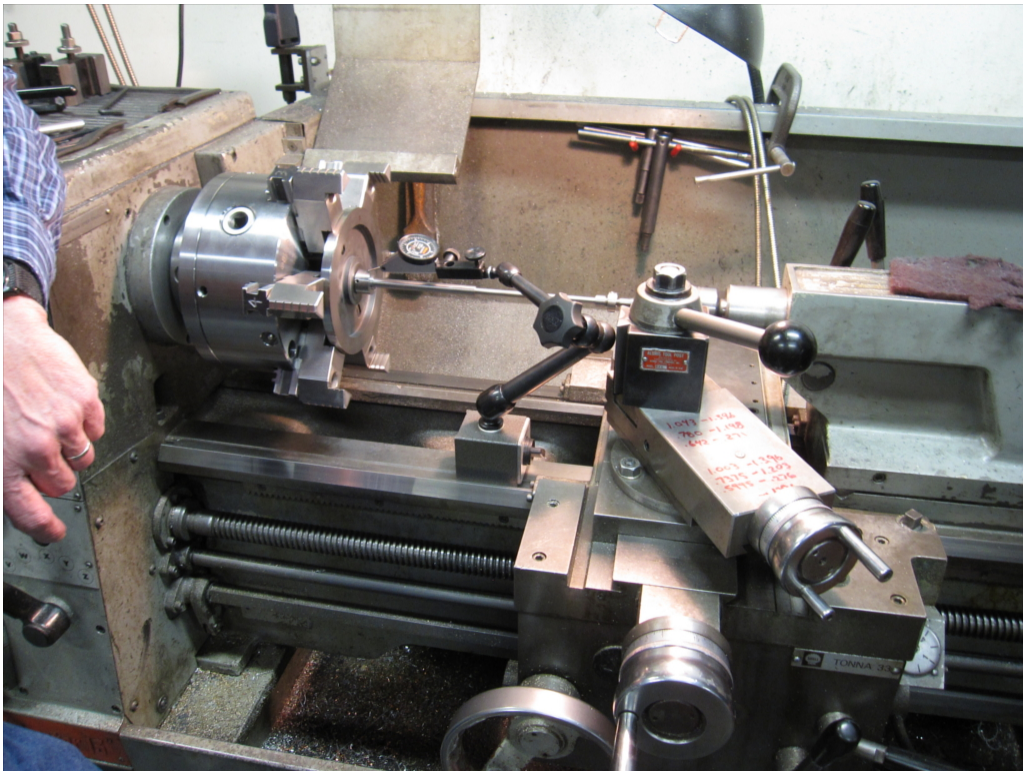
The run out in slider 3 flywheel-shaft assembly (see Figure 9) when the bearings were not attached with Loctite, was  $0.004''$ . Once the bearings were glued to the grating cell attachment hole with Loctite and the Loctite dried out for 1.5 hours, the run out was  $0.0032''$ . Since the improvement was very modest, we decided to clean the bearing and to apply Loctite on both, the inner surface of the bearing hole and the outer surface of the bearing. As an additional precaution, we let the Loctite to dry out overnight. However, the following day we still measured a run out of  $0.003'' - 0.004''$ . The contribution to the run out was measured to be:

- In the flywheel axel:  $\sim 0.0001''$
- In the bearing:  $\sim 0.0002''$
- At the flywheel:  $\sim 0.0027''$

Figure 9: Measuring the run out on the different parts of the flywheel-shaft assembly.

Finally we decided that 0.0027" run out in slider 3 was acceptable. In fact, when the arc was reinstalled and turned the flywheel with the motor powered up, we measured a run out of 0.0011".

The final run out measured in slider 3 with the arc and bearings installed with Loctite was 0.0011".

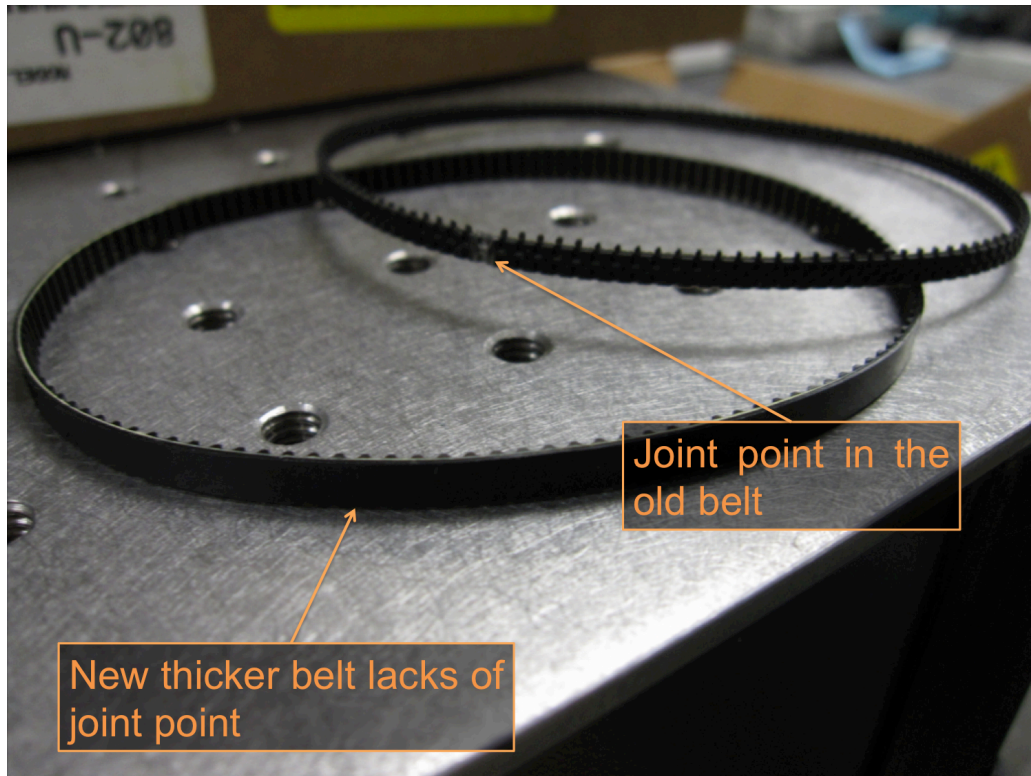
Figure 10: Comparison between the old and new drive belt. The new drive belt is thicker and does not have a joint point, which makes it stronger. Old belts tended to break at the joint point.

One of the major improvements made during this service mission was the replacement of the old pulleys and drive belt in the grating tilt system. The new pulleys are thicker and have a double flange to prevent belts from slipping off. The new belts are wider and have no joint point (see Figure 10) that makes them more robust to breaks.

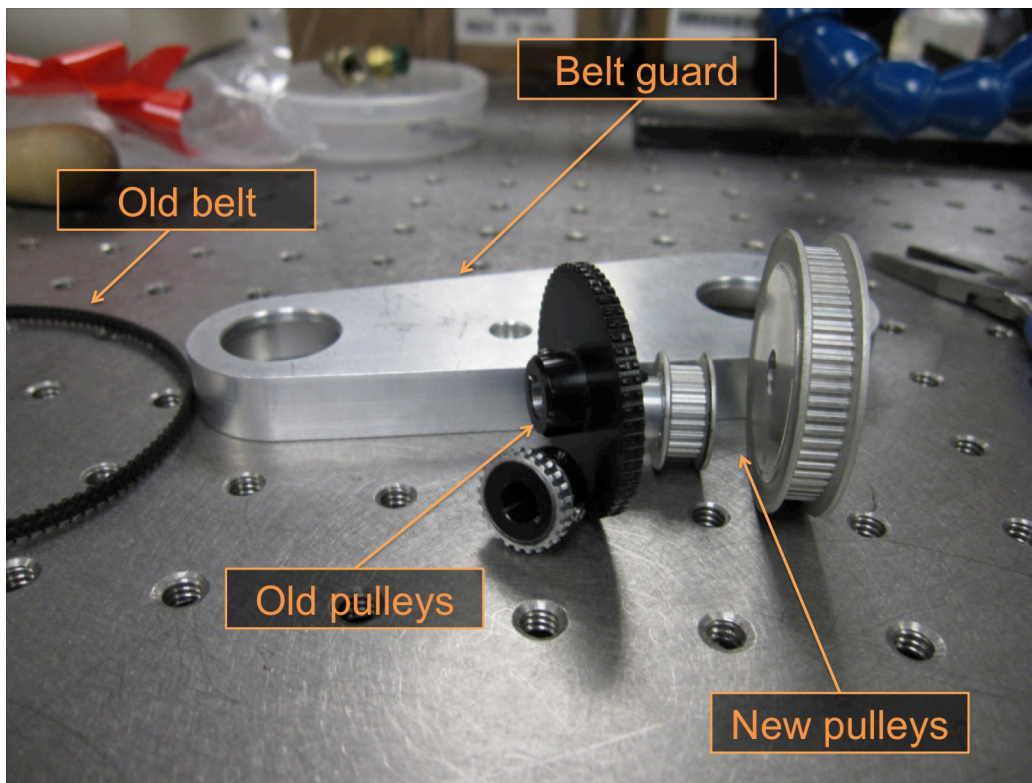
Figure 11: Comparison between the old and new pulleys for the grating tilt system. The new pulley are wider than the old ones and feature a double flange to prevent belts from falling off.

Initial tests of the new parts were done on cell #5, which is available for testing in the summit's instrument lab. New big pulleys had a hub with a tightening bolt (Figure 11). The hub was too thick for clearance to the belt cover. The hub was machined out and the tightening bolt was fitted to the pulley's grooved surface.

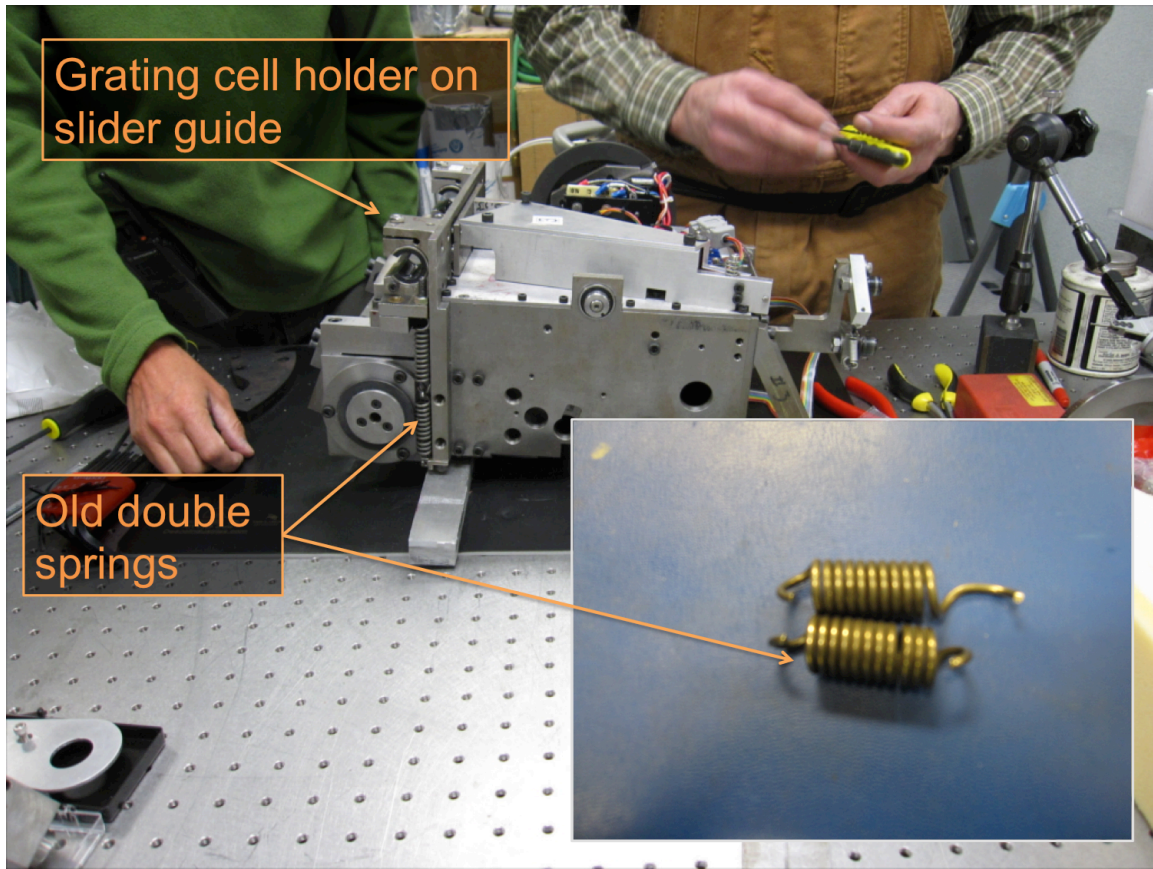
Once the grating cells were assembled they were re-installed in the instrument. During the motion tests after installing the cells, we noticed that the bottom part of grating cell #3 hit one of the kinematic points at the bottom of the slider guide. We concluded this was caused by tension springs (see Figure 12) in the grating cell being too loose. These springs are designed to hold the grating cell in position. However at a rotator angle of -90 degrees at which the grating cell is hanging off the slide guide, the springs would allow a gap between the ball screw enclosure and the rest of the cell. This gap was large enough for the bottom part of the cell to hit the kinematic point.

Figure 12: Tension springs are required to hold the grating cell in position when the grating is unclamped. During the service mission we replaced the old double springs (in the figure) with new single springs because the old ones had gone beyond their elastic limit (see inset).

The best rotator orientation to adjust the spring tension was -120 degrees. Spring tension was adjusted by turning the spring tension screw. The outer length of the tension screw was used as a proxy to the tension measurement. The following table shows the different tension adjustments (screw length) we performed.

Tightening the springs such that the tension was maximized cleared the condition for the cell #3 to hit the kinematic point. However, even with the maximum tension

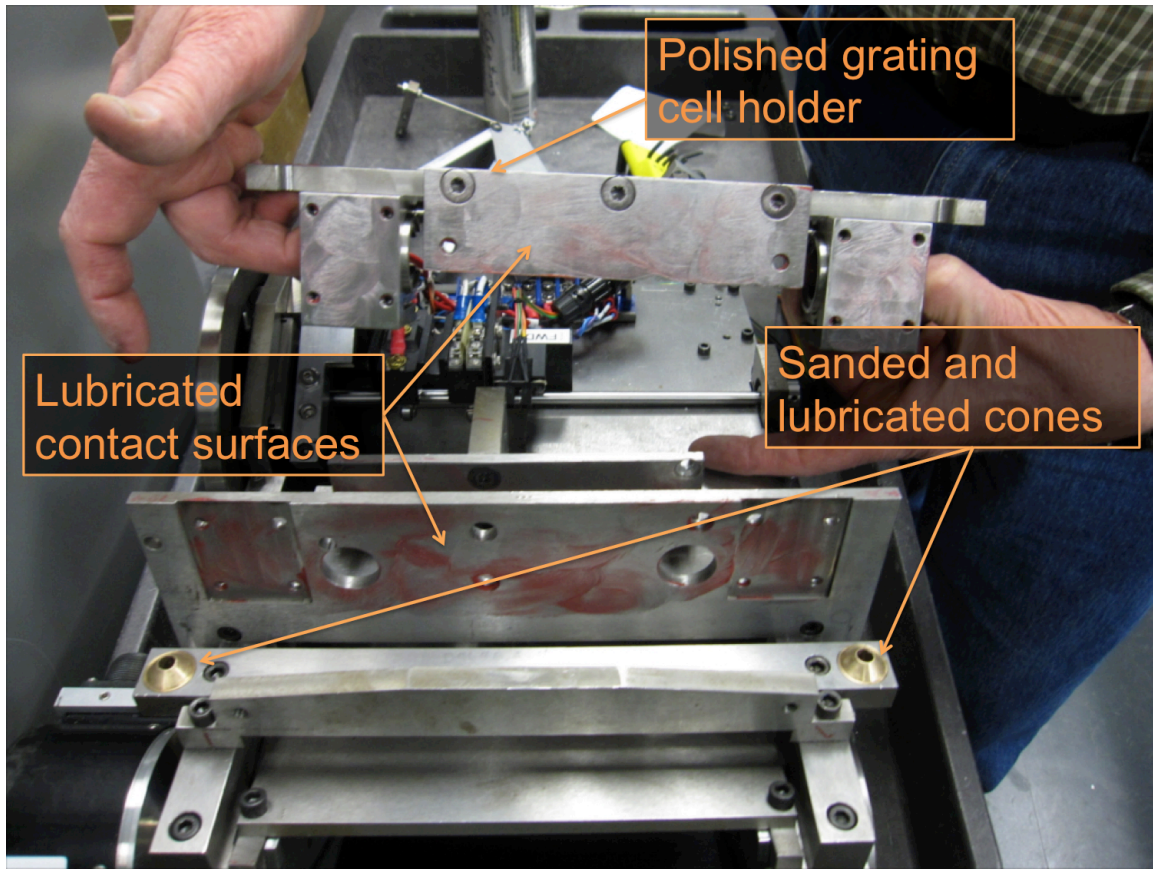
Figure 13: Contact surfaces and guide cones were lubricated to facilitate the cell repositioning after unclamping. Cones were sanded and flat metallic contact surfaces were polished before lubrication.

- Cleaned and sanded defining cones.
- Polished contact surfaces of moving parts.
- Lubricated cone surfaces and other surfaces that come in contact when the clamp is released. Two different types of lubricants were tested; Mobile 1 and vacuum grease. We finally used Mobile 1 because it seemed to give better results.
- Installed new and stronger springs. These new springs were slightly oversized but this was not a problem.

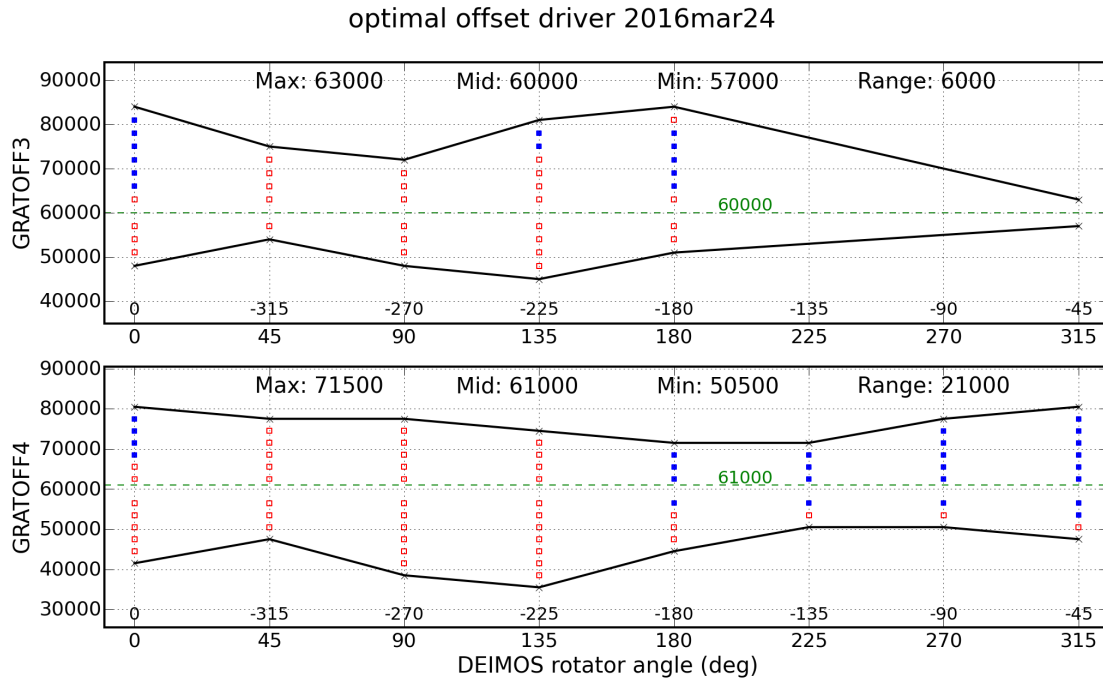
This section shows a series of clamping tests as a function of the rotator angle to determine the optimal value of the GRATOFFn keyword. Figure 15 shows the first clamping tests with the instrument closed after the service mission. The previous figure shows that clamping was not possible at all angles for slider 3. Clamping was successful at all rotator angles for slider 4, although the pin did not insert first in many cases (e.g. rotator angles 45 to 135).

Figure 15: Clamping curves for sliders 3 (top panel) and 4 (bottom panel). Blue filled squares represent successful clamp ups where the pin went in first. Red open squares represent successful clamp ups where the pin did not go in first. Black crosses represent offset values at which clamping was not successful. Those angles for which there are no symbols (e.g. slider 3 at rotator angles 225, 270 and 315) correspond to unsuccessful clamp ups in the whole offset range. The green dashed line shows the optimal clamping value. The maximum offset value at which the grating could be clamped at any rotation angle is shown as the 'Max:' plot annotation. In the same way, the minimum offset value, mid (optimal) value and range are shown as annotations.

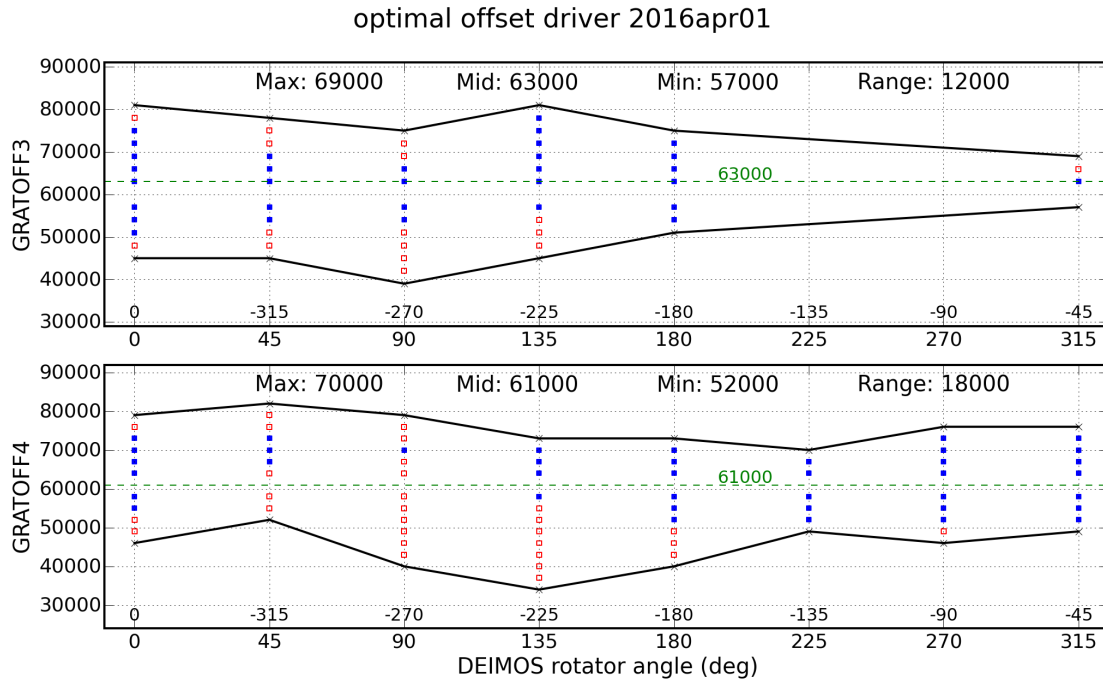
Figure 16: Clamping curves for sliders 3 (top panel) and 4 (bottom panel) obtained on April 1. See Figure 15 for an explanation of the symbols.

The clamping tests performed on April 1 (Figure 16) show a slightly general improvement with respect to March 16 (Figure 17). Clamping with the ping going in first occurs more often on April 1 than on March 16 for both sliders. However, the region of the rotator where slider 3 cannot clamp up is the same in both dates.

Manual adjustments were done to try to improve the clamping performance in slider 3 and a new battery of tests was run on April 1, 2016. The results are displayed in Figure 16.

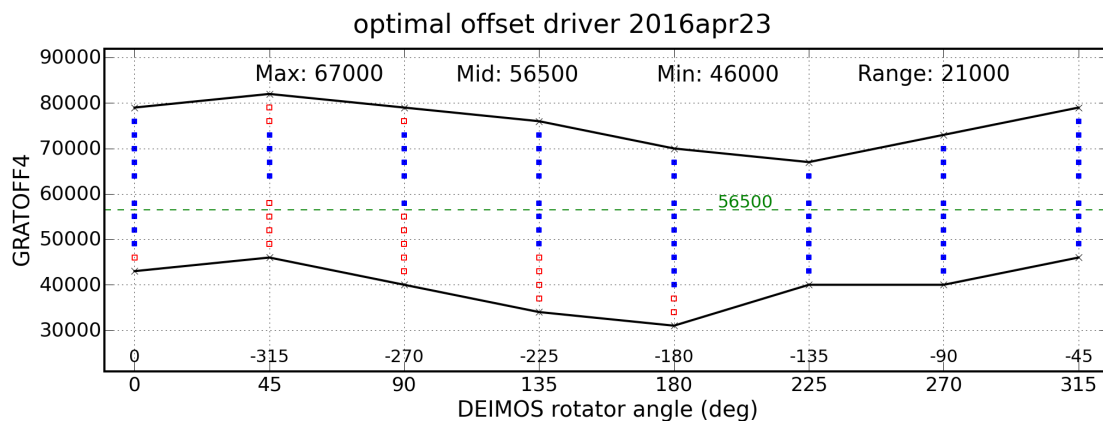
Figure 17 shows the clamping performance in slider 4 on April 23. There was a clear improvement in clamping performance, since the range of offsets at which slider 4 clamps successfully with the pin getting in first is larger than in previous dates.

Figure 17: Clamping curve for slider 4 obtained on April 1. See Figure 15 for an explanation of the symbols.

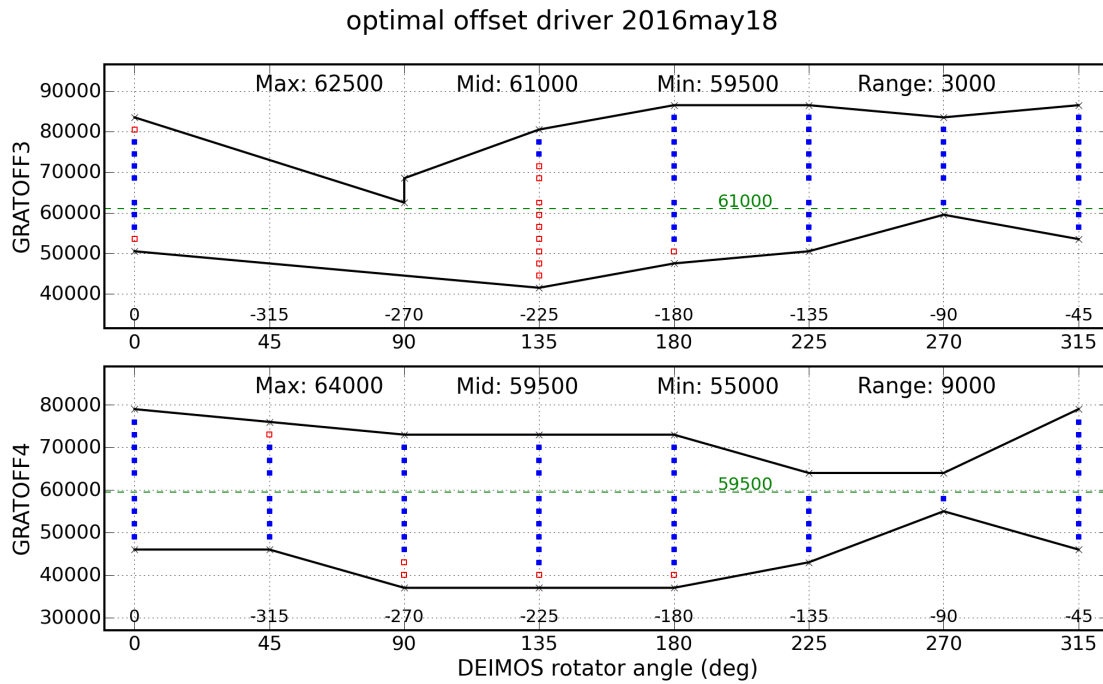
Figure 18: Clamping curves for sliders 3 (top panel) and 4 (bottom panel) obtained on May 18. See Figure 15 for an explanation of the symbols.

The latest situation regarding clamping performance after the service mission is that slider 4 can be clamped at any rotator angle, but there is a range of rotator angles (-315 to -270 deg) where clamping is unsuccessful for slider 3.

Two more sets of adjustments and tests were performed during May. Figure 18 shows the latest clamping curves for sliders 3 and 4.

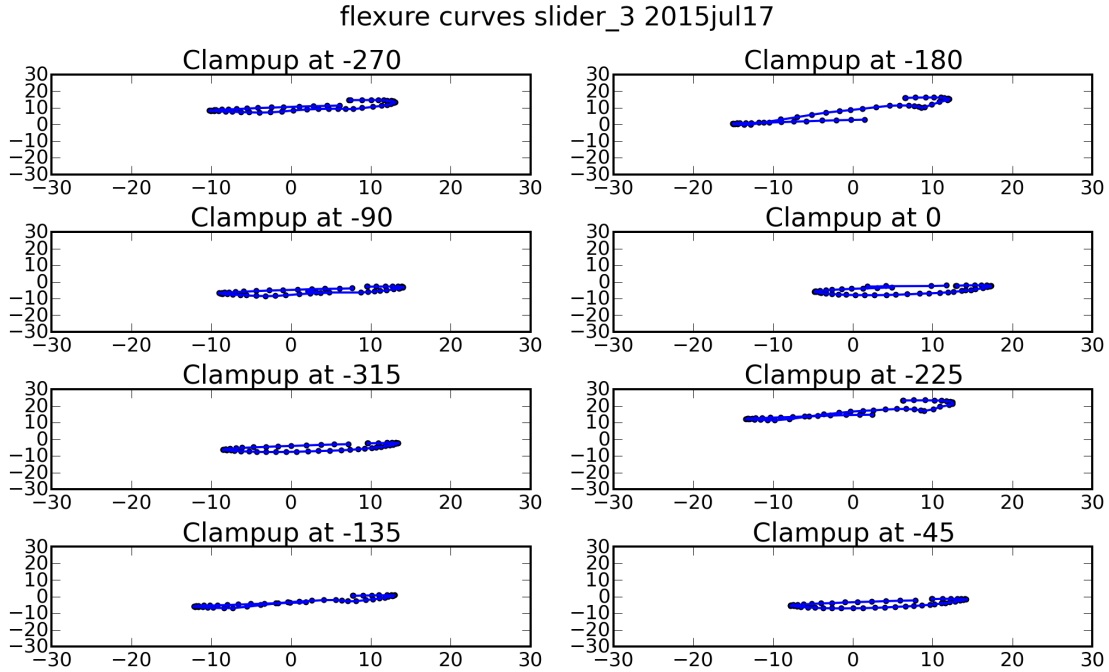
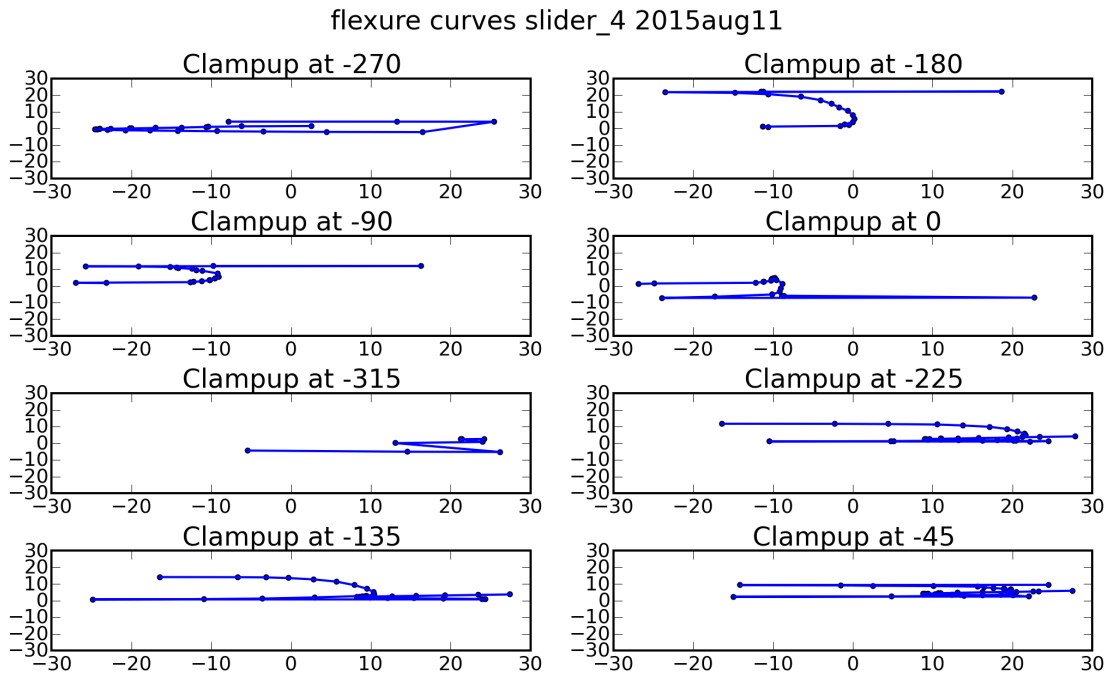
Figure 19: Flexure curves for slider 3 before the current service mission. The X and Y axes in each panel represent the FCS cross-correlation offset with respect to the initial position. In each curve, the rotator was jogging from -180 to 180 degrees once the grating was clamped up at the rotator angle indicated in each plot title. Each axis range covers the correction range of the FCS.

Figure 20: Flexure curves for slider 4 before the current service mission. See Figure 19 for a description of the plots.

Before the second service mission, slider 3's flexure range was within the FCS correction range, however, slider 4 was off range for several clamping angles. Based

on the curves in Figure 19 and Figure 20, we decided to always clamp slider 3 at a rotator angle of -30 degrees and slider 4 at an angle -180 deg. This was the work around for all observing with DEIMOS prior to the second service mission.

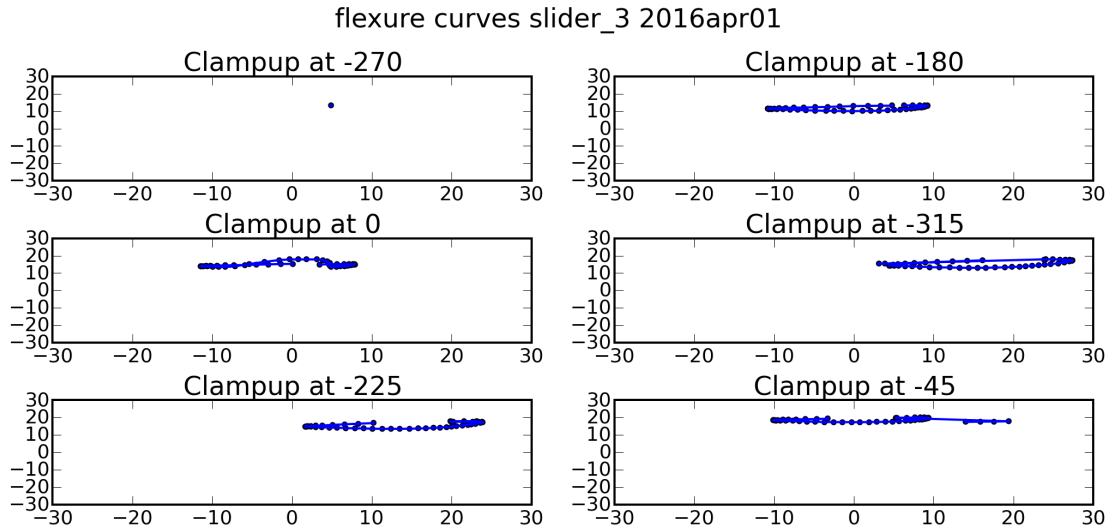
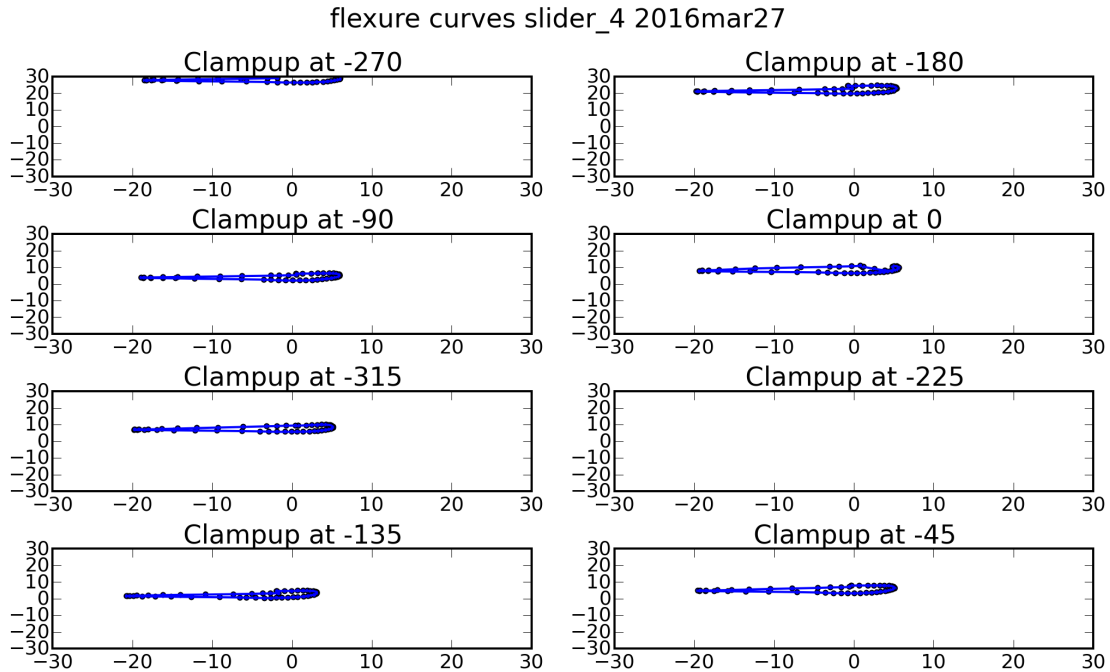
Figure 21: First flexure curves for slider 3 obtained after the current service mission. See Figure 19 for a description of the plots.

Figure 22: First flexure curves for slider 4 obtained after the current service mission. See Figure 19 for a description of the plots.

Slider 3 looked worse than before the service mission, because after the mission it was not possible to clamp it at some of the rotator angles (-90 and -135 deg). Besides, the curves looked irregular and broken. This means that the FCS may struggle to perform the appropriate flexure corrections. However, slider 4 improved considerably after the mission. Slider 4 would not only clamp at any rotator angle, but the flexure curves looked fairly uniform as compared to the situation previous to the service mission (compare Figure 20 and Figure 22).

Several attempts were made to fix the problem with slider 3 and to try to improve slightly the behavior of slider 4. One of these attempts was very fruitful for slider 3, which improved enormously (see Figure 23). However, the modifications led to a situation with slider 4 flexure increasing.

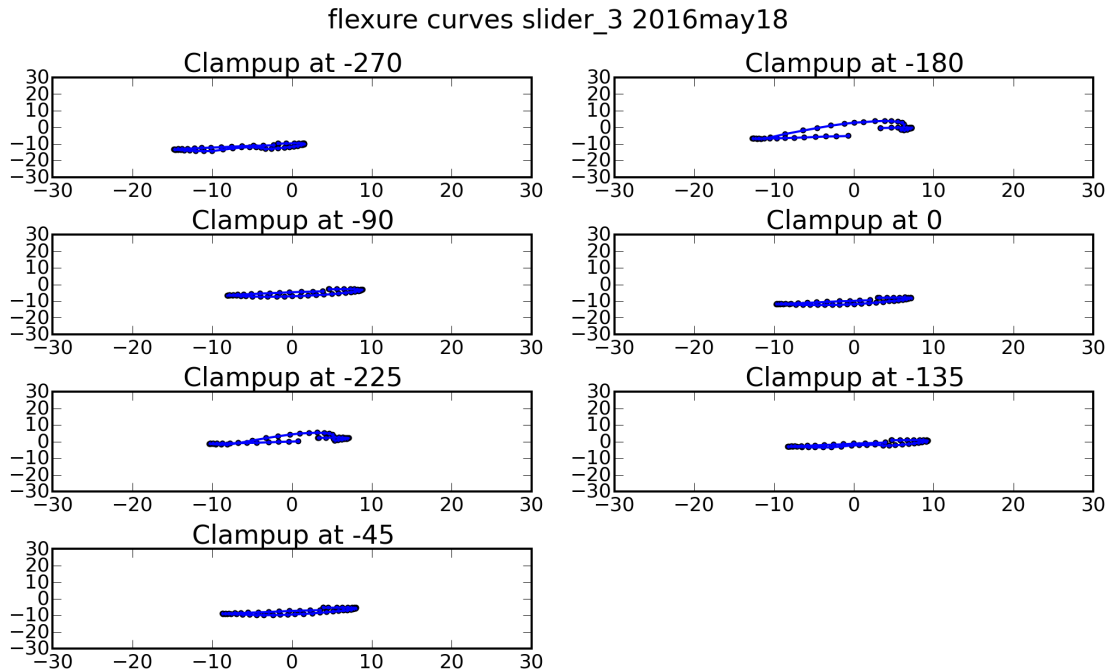
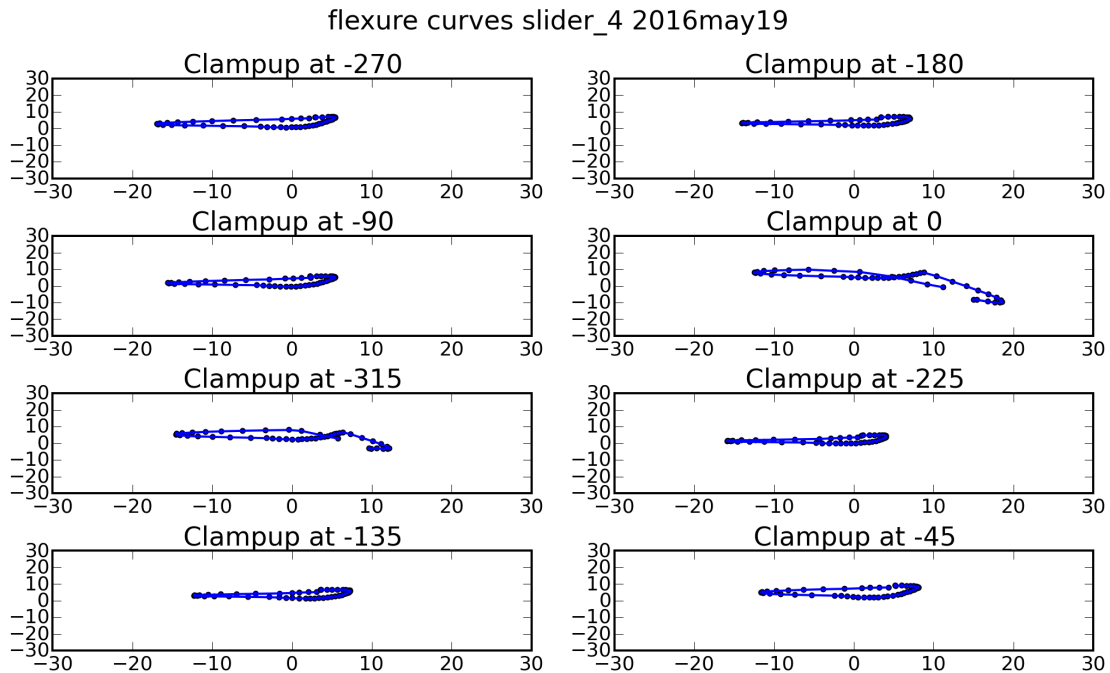
Figure 25: Latest flexure curves for slider 3 obtained after the current service mission. See Figure 19 for a description of the plots.

Figure 26: Latest flexure curves for slider 4 obtained after the current service mission. See Figure 19 for a description of the plots.

As it can be inferred from the two previous figures, the flexure curves for both sliders are uniform and within the FCS correction range at all clamping angles. This represents a considerable improvement with respect to the situation we had before the service mission.

Additional fine-tuning in the clamps and in the clamping pin was performed during May. These latest modifications have resulted in flexure curves for both gratings that are considerably better than before the service mission (see Figures 25 and 26).
