LRIS Blue Channel Shutter History

Updates	Author
2006 September 27 Original Version	Marc Kassis
2010 June – Following Failure	Marc Kassis

This document is a status report for the suite of blue side shutters in use at the Keck Observatory. This is to provide a history of service and track when the shutters have been replaced inside LRIS.

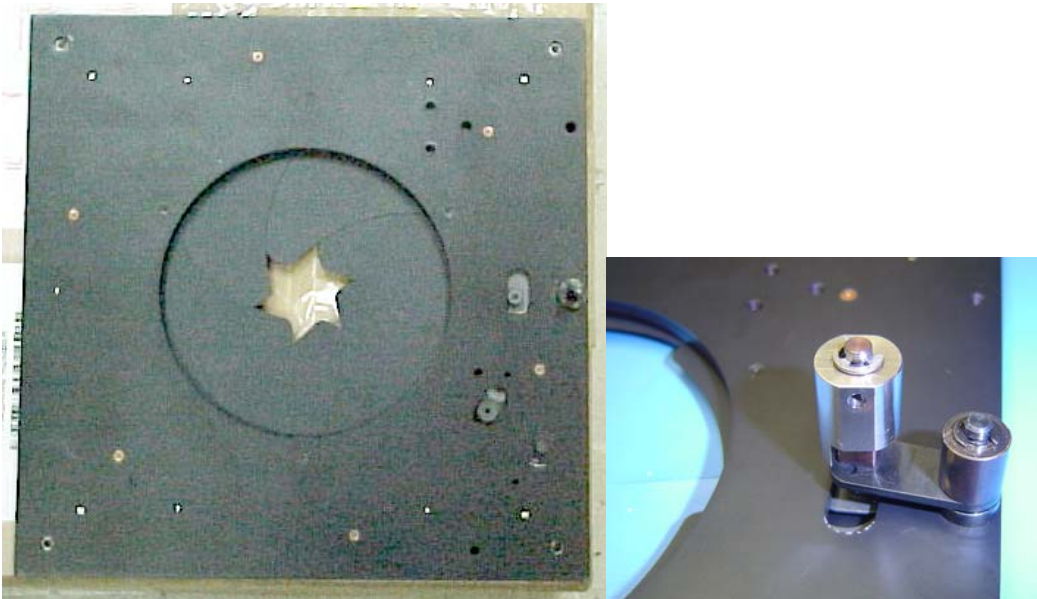
Figure 1: Face on view of a Pronto E/100 shutter used on the LRIS blue channel (left). The shutter is slightly open. The pivot arm has been removed in this view. At right, the pivot arm and custom pin are shown. The thin rods thread in the tapped hole seen in this view of the custom pivot pin.

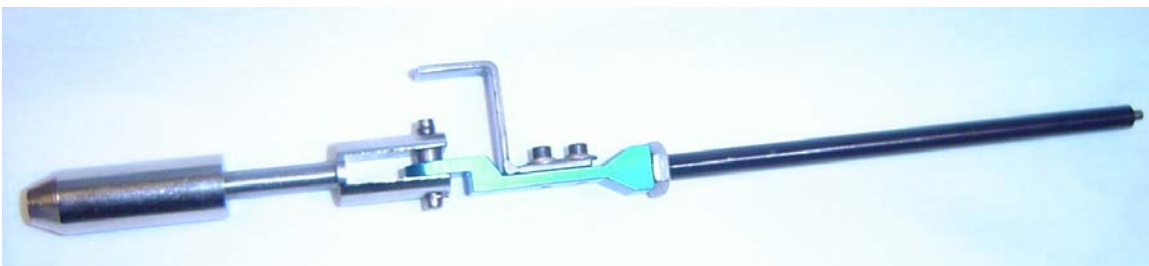
Figure 2: Assembly of the armature and the thin threaded rod. The armature at the left of the image fits inside a solenoid.
