# DEIMOS Service Mission, March 2016

*C. Alvarez, M. Kassis, S. Milner, J. Ward, E. James, A. Vandenberg*

This document reports on the service mission performed on the DEIMOS grating system between March 13 and March 28, 2016. The main work done on the system consisted of the following tasks:

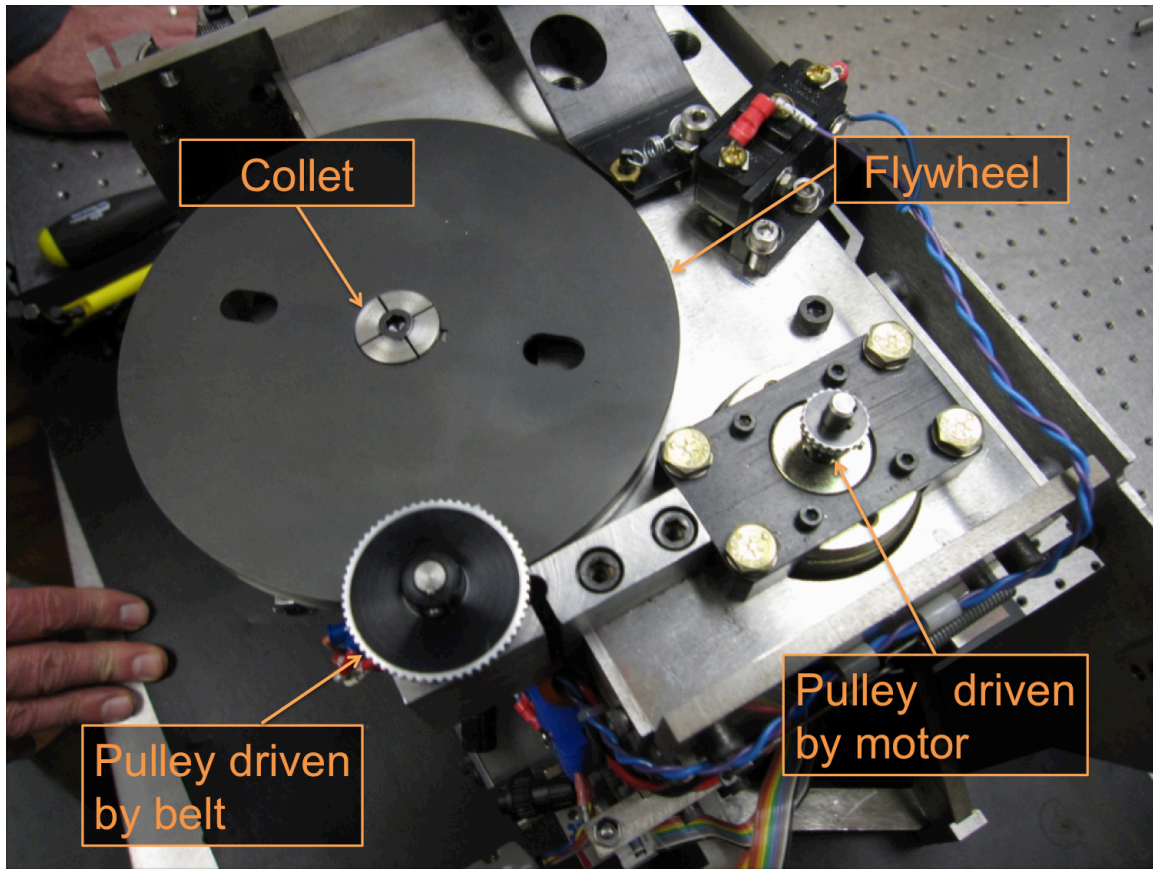
Figure 3: Some of the main components of the grating tilt mechanisms replaced during the service mission.

- Installed new pulleys in the grating tilt mechanism that are thicker and have a flange to prevent belts from falling off (see Figure 3 for a general view of the grating tilt mechanism).

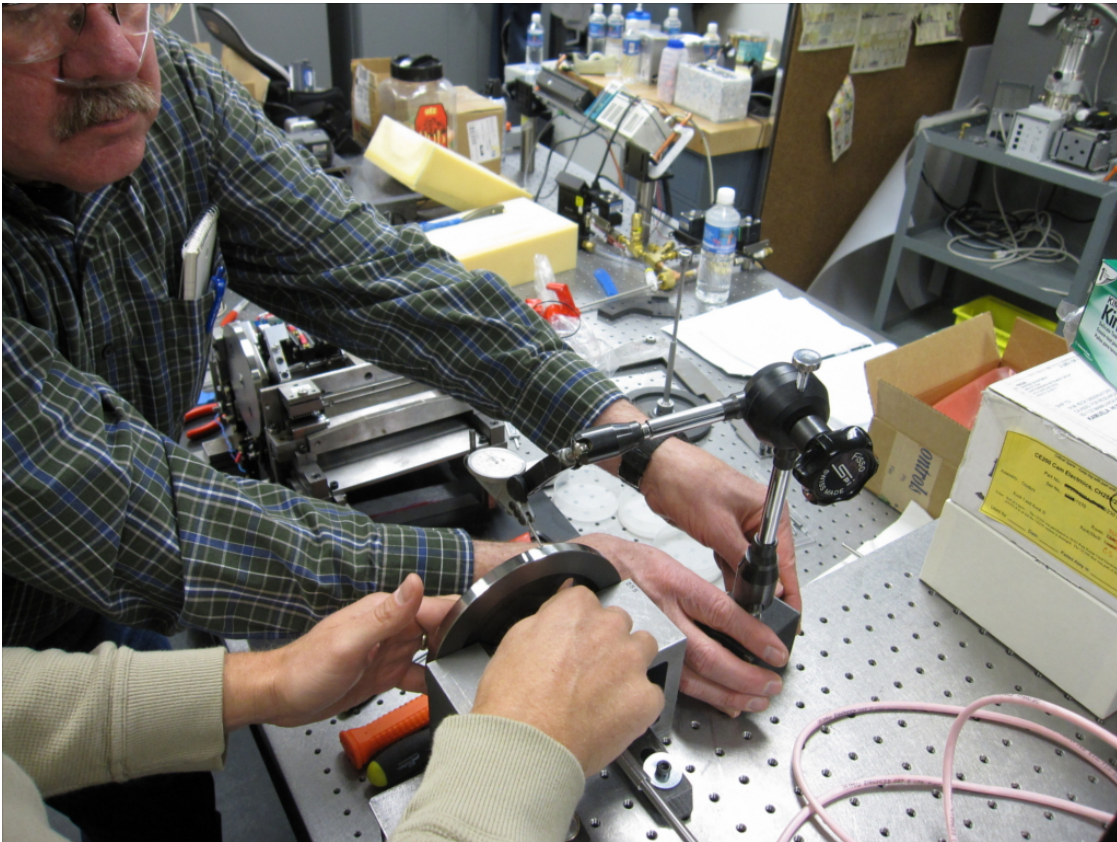
- The new flywheel assembly on slider 3 was not round to at least 0.002". This was true for the two spares as well.
- The pressure of the arc on the flywheel shaft did not make any difference in the roundness of the flywheel measurement for either of the grating cells.

Figure 7: Jim and Marc measuring the roundness on the flywheel.

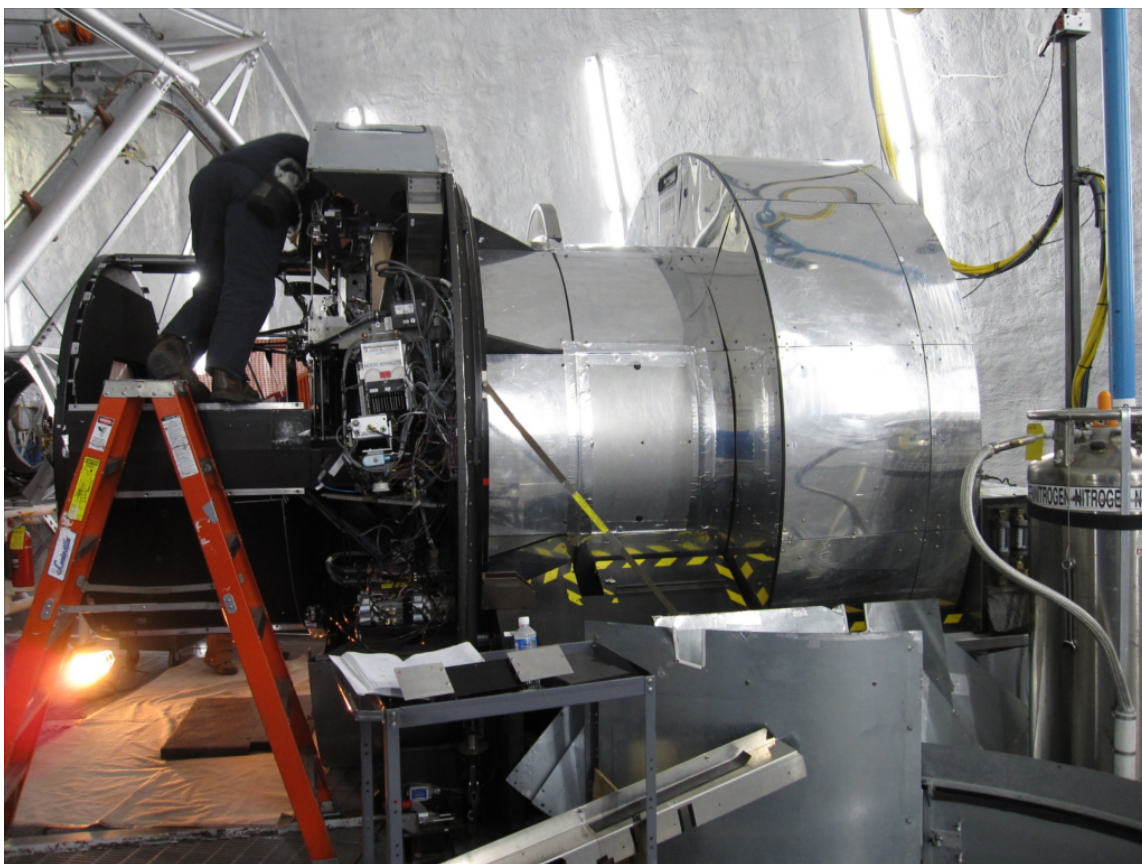
Figure 14: Steve adjusting and inspecting the clamps during initial clamping tests with the instrument still open.

We found that clamp #4 in slider 3 was not clamping properly. Different combinations of shims in the clamp were used to make sure the clamp's foot made tight contact with the clamping surface. Shims combinations went all the way from no shims at all to up to 0.0057" total thickness. New thicker shims were machined to facilitate the addition and removal of thickness to the clamping surface. We noticed that when clamp #4 went in position the first time there was no gap between the foot and the clamping surface. However, when clamp #5 was tightened and #4 went back in, there was a gap between clamp #4 foot and the clamping surface.

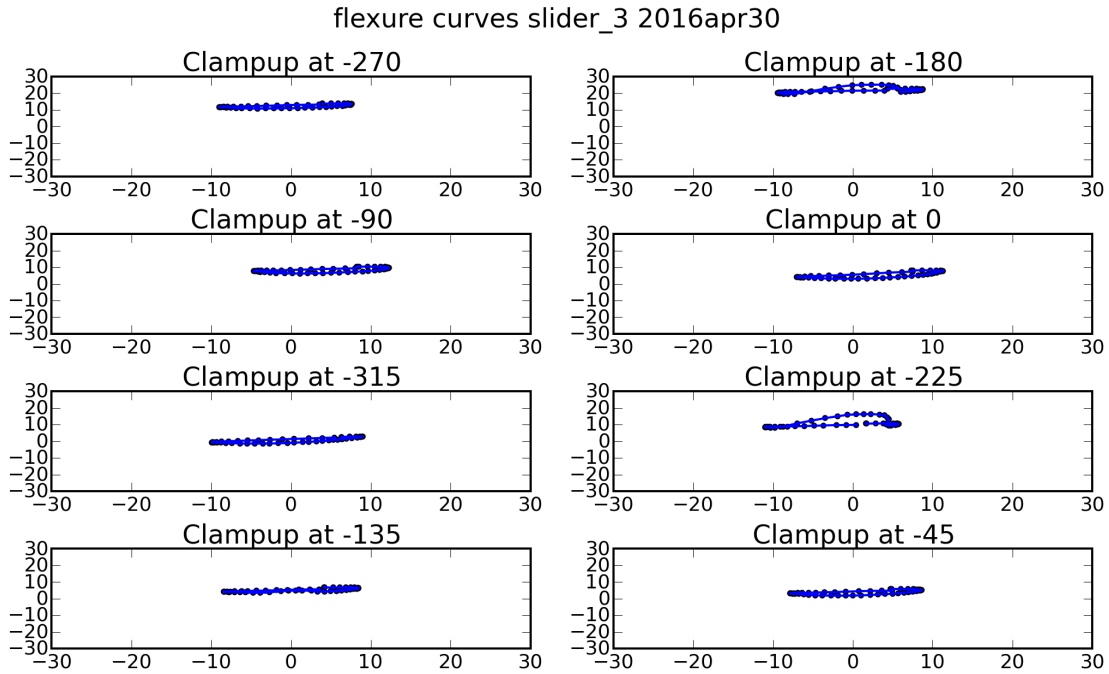
Several attempts were made to fix the problem with slider 3 and to try to improve slightly the behavior of slider 4. One of these attempts was very fruitful for slider 3, which improved enormously (see Figure 23). However, the modifications led to a situation with slider 4 flexure increasing.

Figure 23: Latest flexure curves for slider 3 obtained after the current service mission. See Figure 19 for a description of the plots.

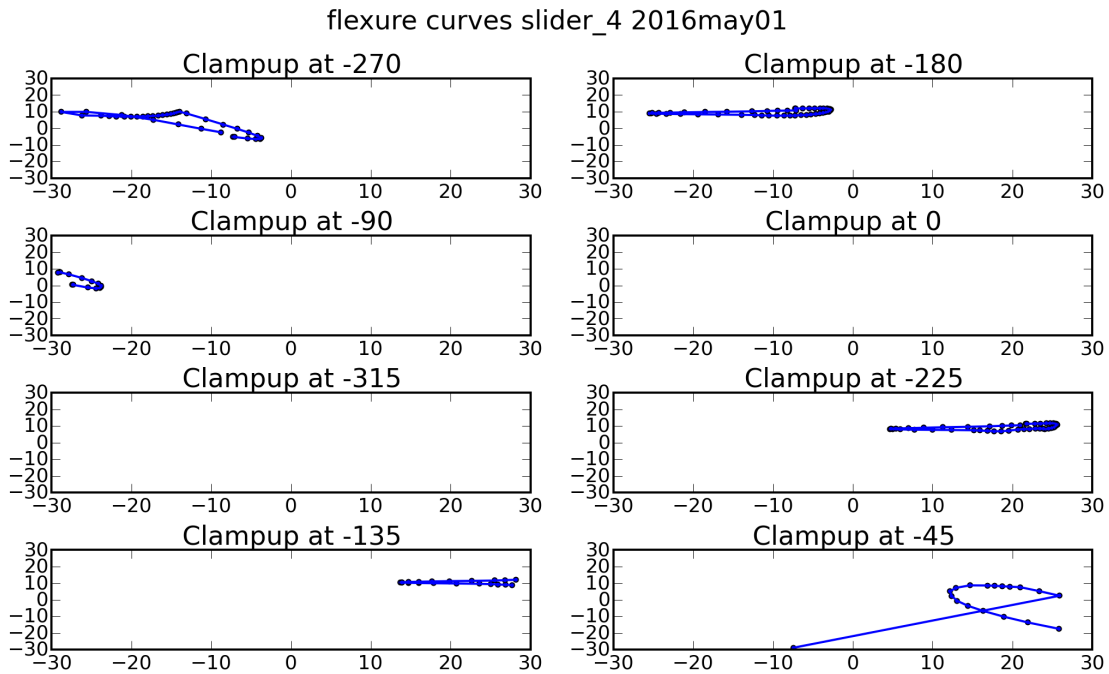
Figure 24: Latest flexure curves for slider 4 obtained after the current service mission. See Figure 19 for a description of the plots.

Additional fine-tuning in the clamps and in the clamping pin was performed during May. These latest modifications have resulted in flexure curves for both gratings that are considerably better than before the service mission (see Figures 25 and 26).
